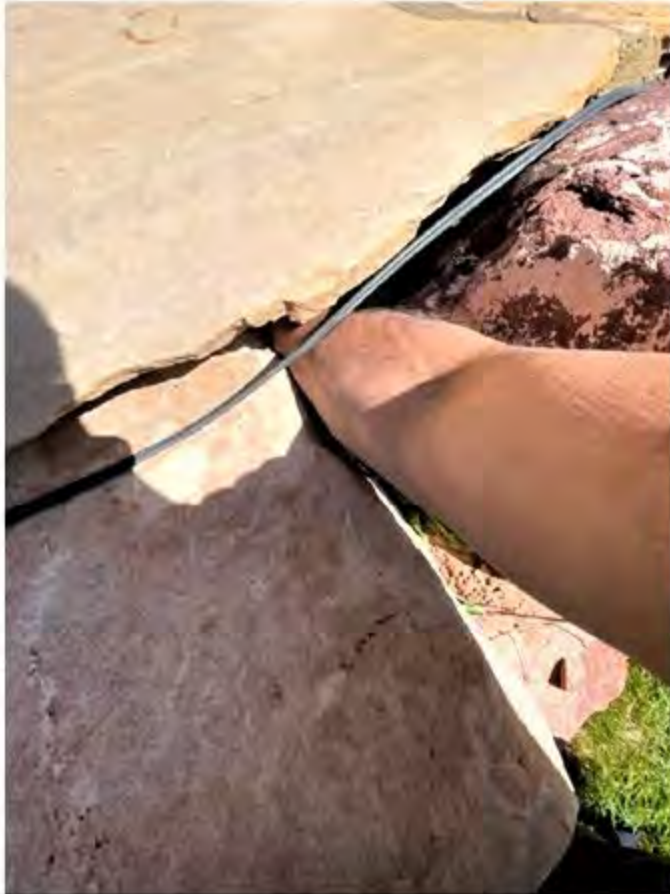
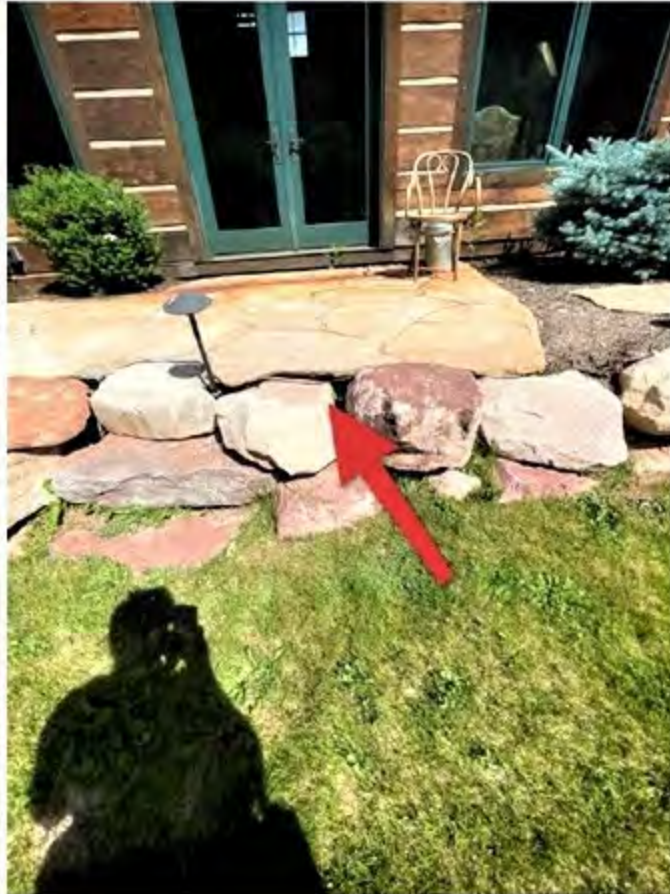
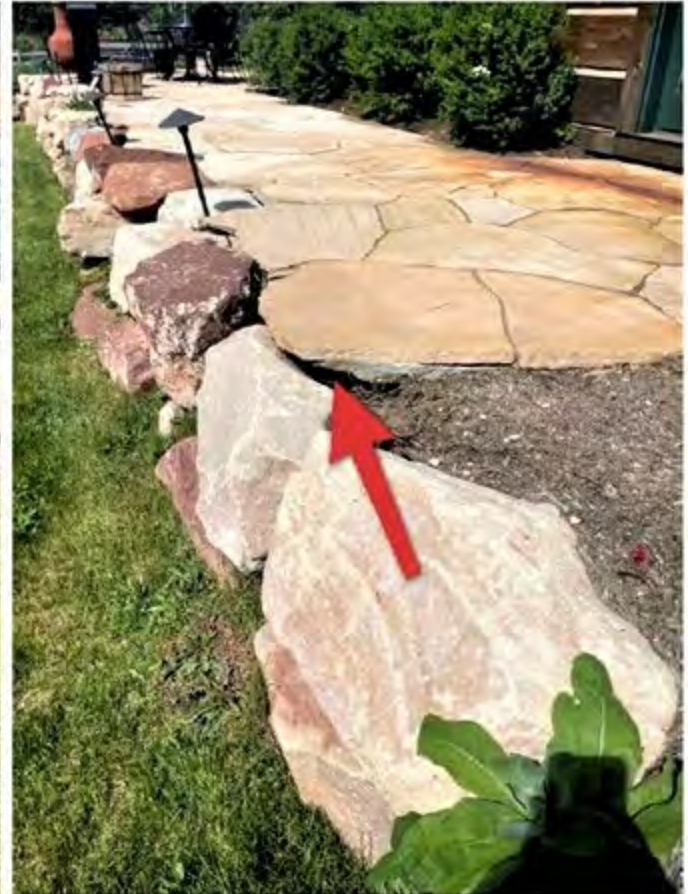
5.2.1 Patio condition

UNDERMINED

Further review/ Monitor

The patio surface was observed to be undermined by soil erosion. We recommend that the patio be repaired as required to present-day industry trade standards for the safe use of affected areas.

Recommendation
Contact a qualified professional.
