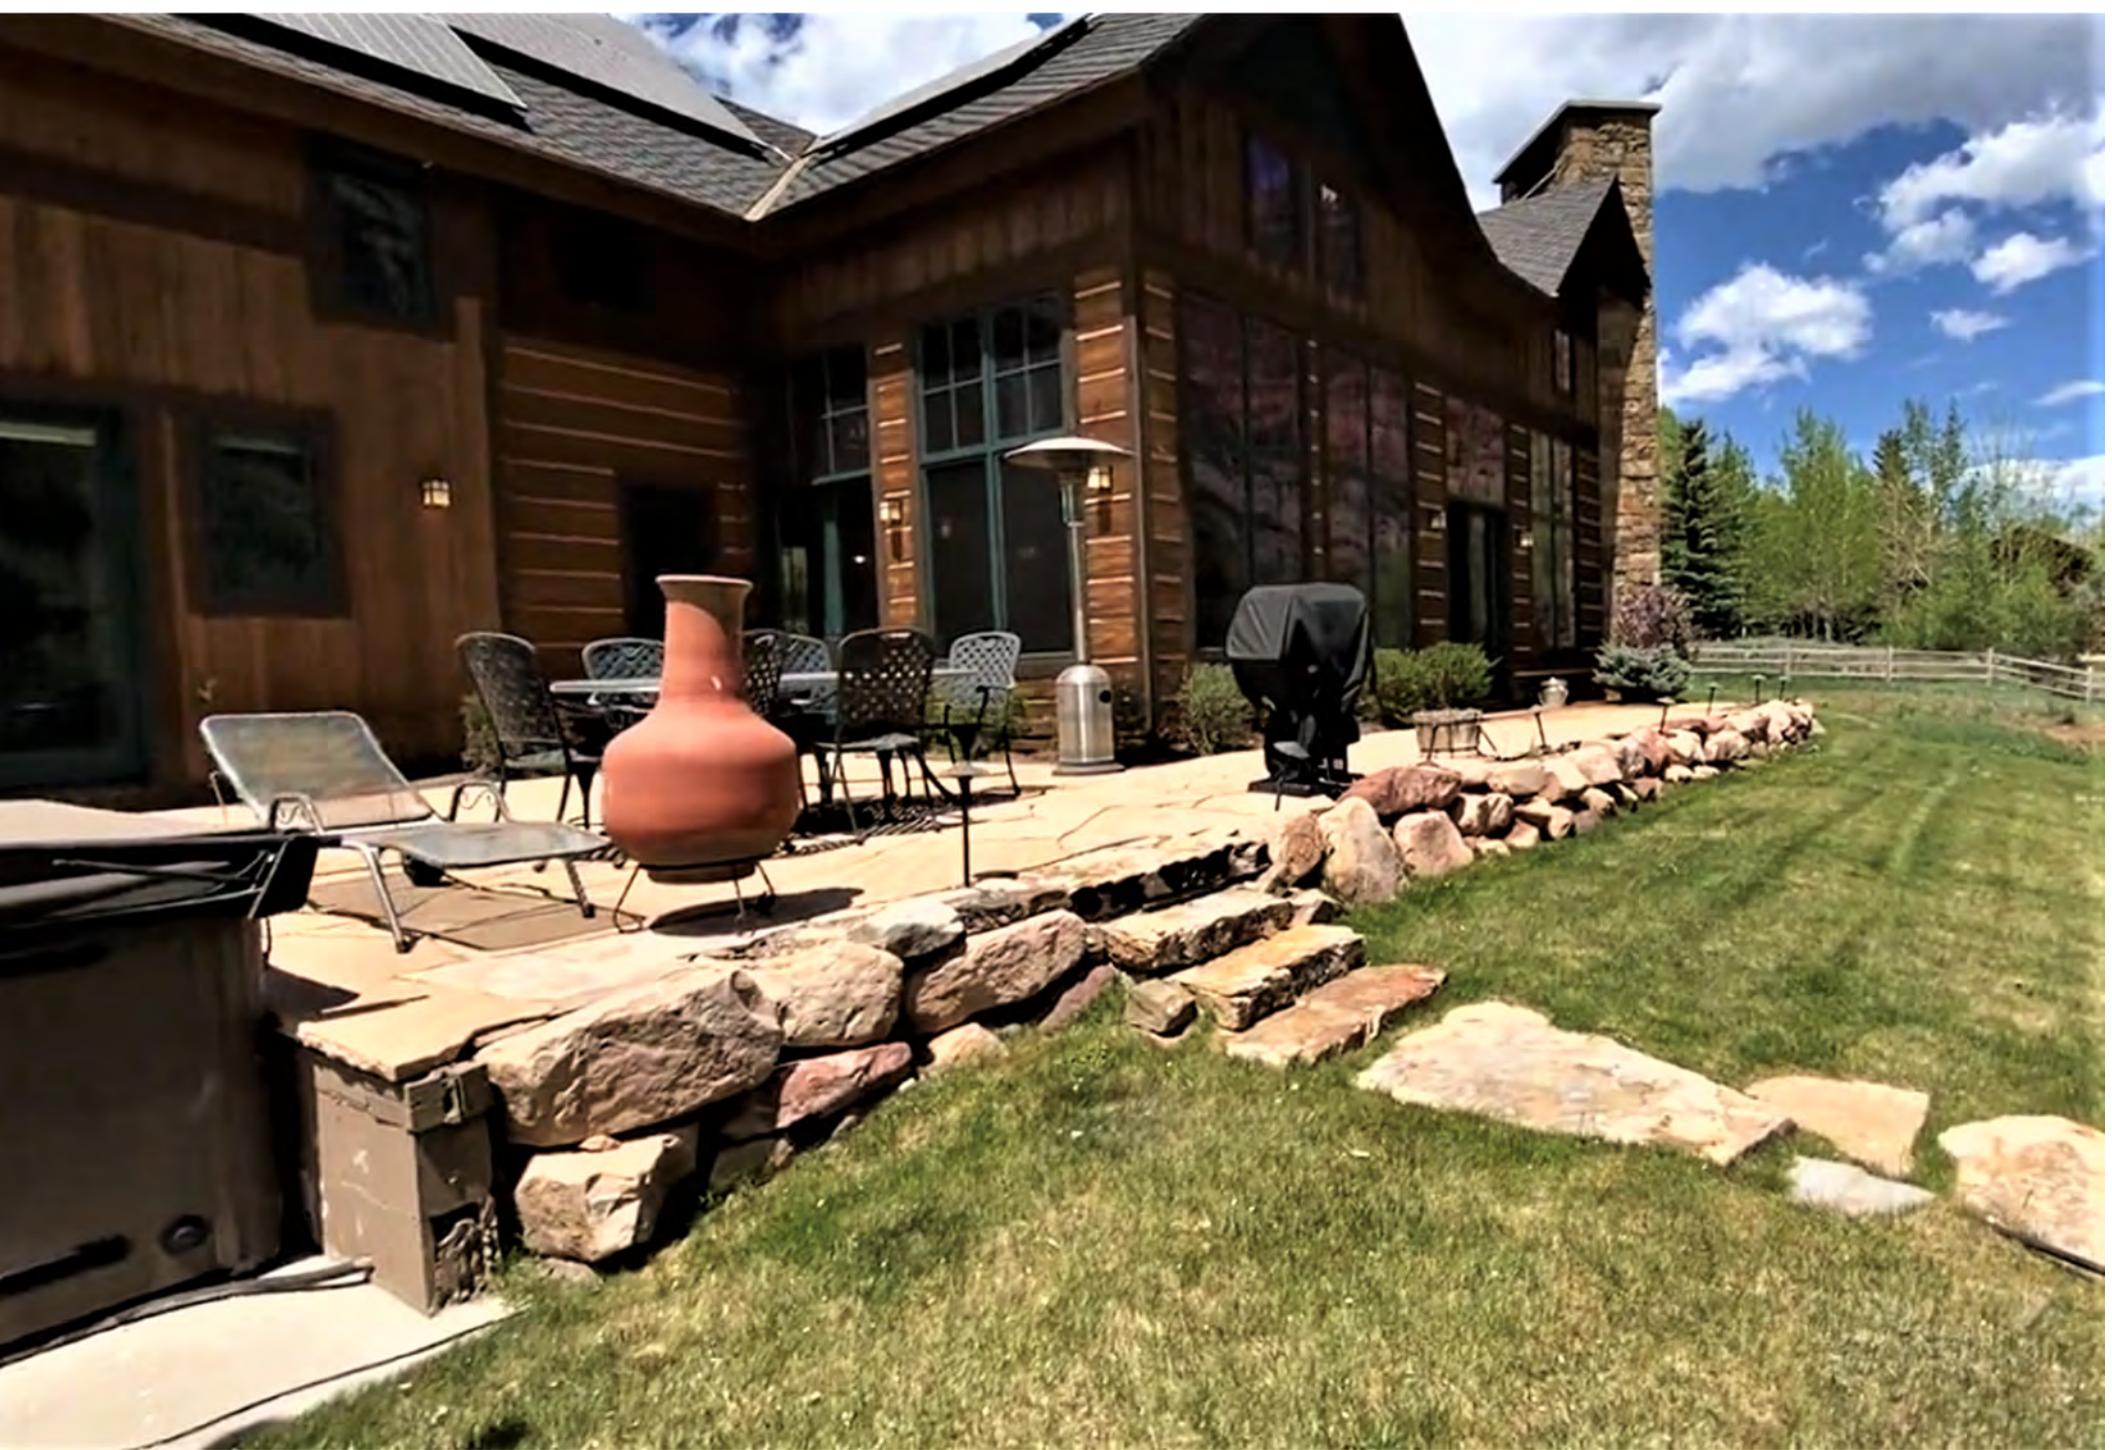
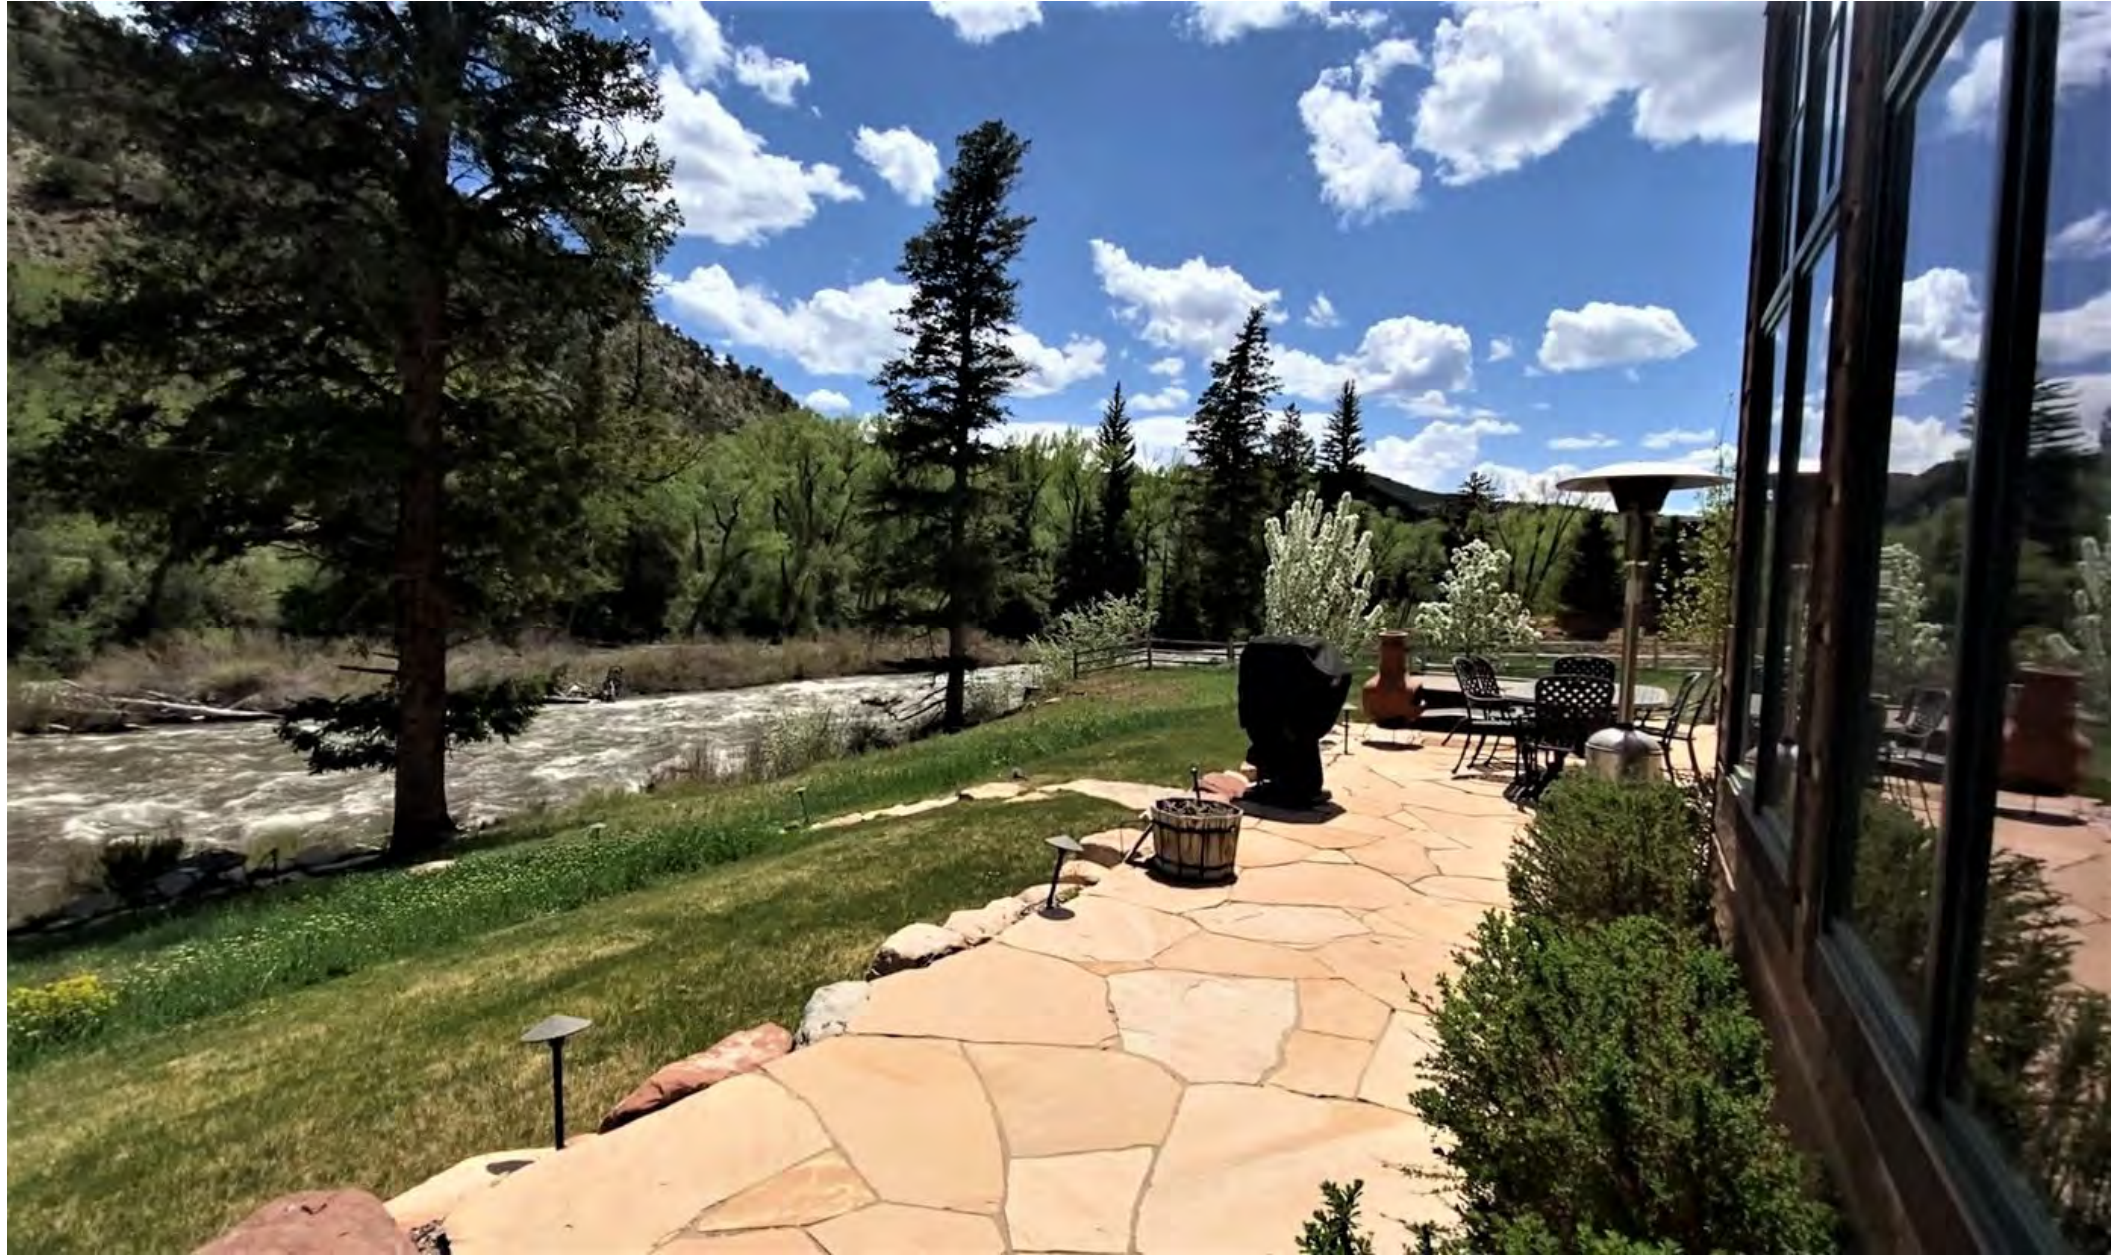
5.2.1 Patio condition

UNDERMINED

The patio surface was observed to be undermined by soil erosion. We recommend that the patio be repaired as required to present-day industry trade standards for the safe use of affected areas.

Further review/ Monitor

Recommendation
Contact a qualified professional.
